PRELIMINARY
KNKT.11.05.10.04

Aircraft Accident Investigation Report

Xi An MA60; PK-MZK

**Utarom Airport, Kaimana - Papua Barat
Republic of Indonesia**

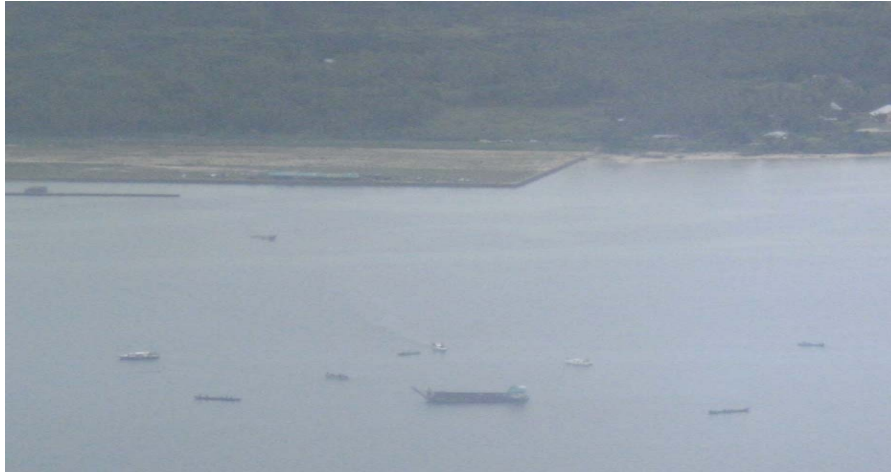
Figure 2 The Accident Site

The accident site was about 800 meters south west of the beginning of runway 01 or 550 meters from the coastline. The position of main wreckage is Latitude 03° 39' 8" S; Longitude 133° 41' 15" E. Most of the wreckages were submerged at the shallow sea between 7 down to 15 meter deep.

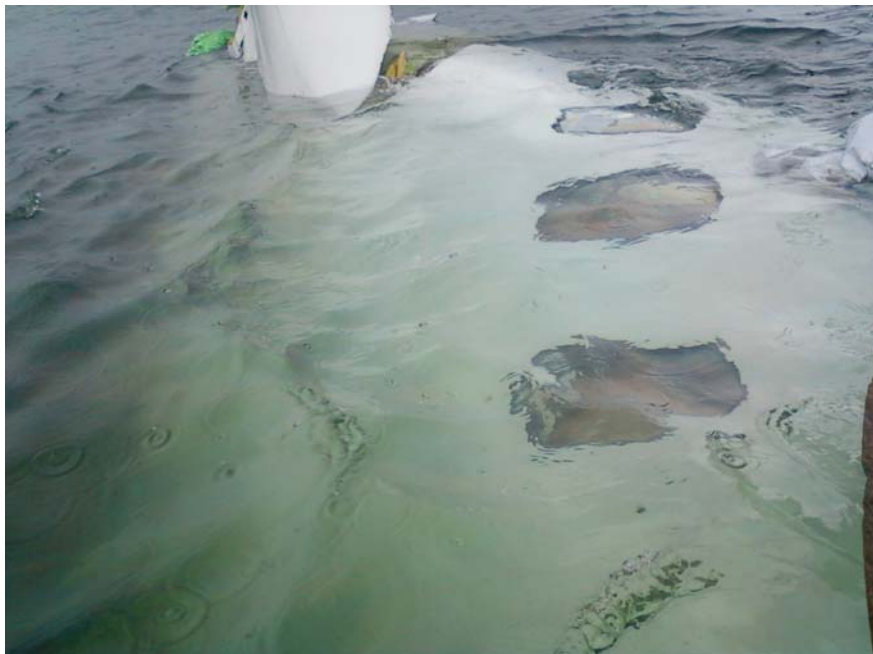
Figure 3 Fuselage a Few Minutes after Impact

The accident site was about 800 meters south west of the beginning of runway 01 or 550 meters from the coastline. Most of the wreckages were submerged at the shallow sea between 7 down to 15 meter deep.

Small parts of the aircraft were recovered from the coast, while four large parts such as two broken fuselages, wings included engine and landing gear, and empennage.
